**TITLE** : Report on the evaluation of the fire properties of the **RIGIFOAM** product **LAMBDABOARD WM/MN (100 mm)** as under-roof insulation material using the **SANS 10177 – Part 11** test protocol in terms of **SANS 428**

**REQUESTED BY** : RIGIFOAM  
3 Detroit Street  
Apex  
**BENONI**

**CONTRACT No** : FTC14/120

**DATE** : 29 October 2014

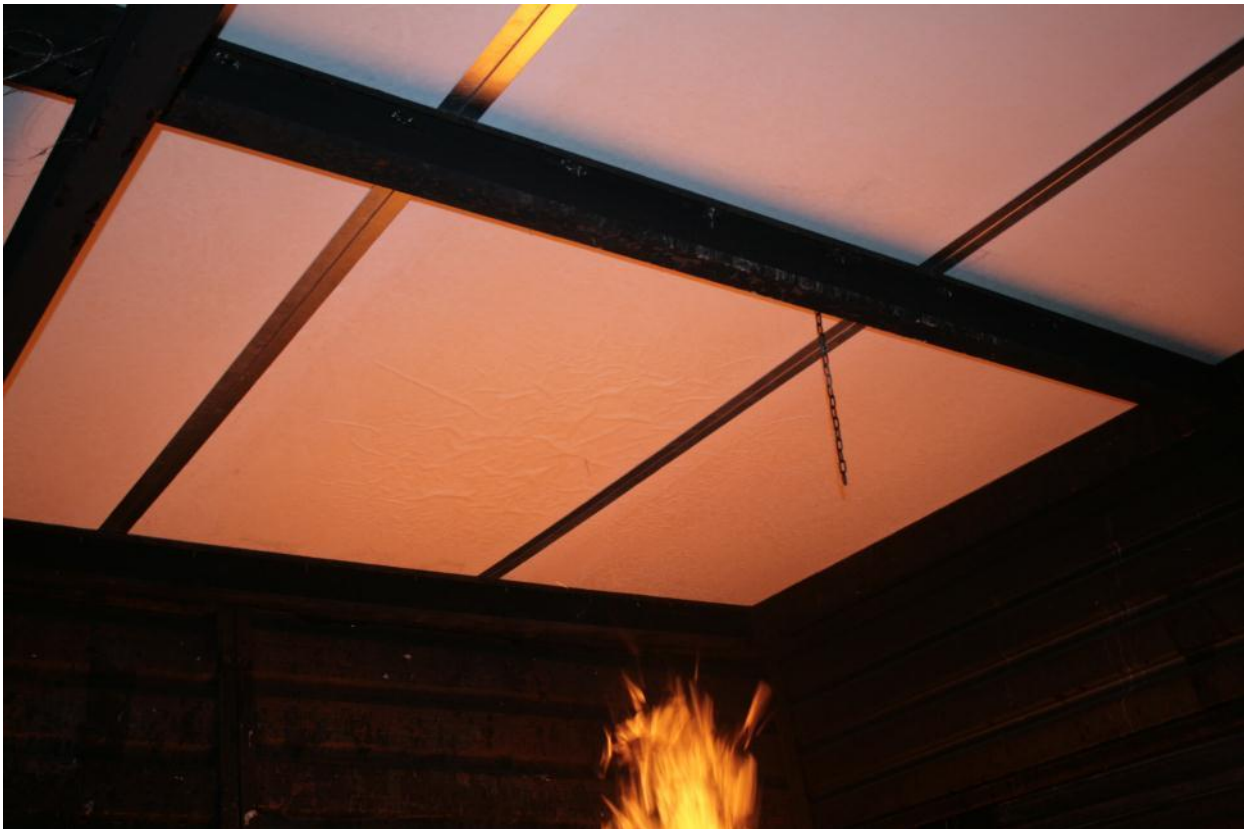
Figure 4.1.4: Note the wrinkling of the facing material above the fire source.

No flame spread other than sporadic ignition above the fire source area was observed during the entire test period. The facing material wrinkled during the early stages of the test which resulted in delamination and discolouration of the facing material.

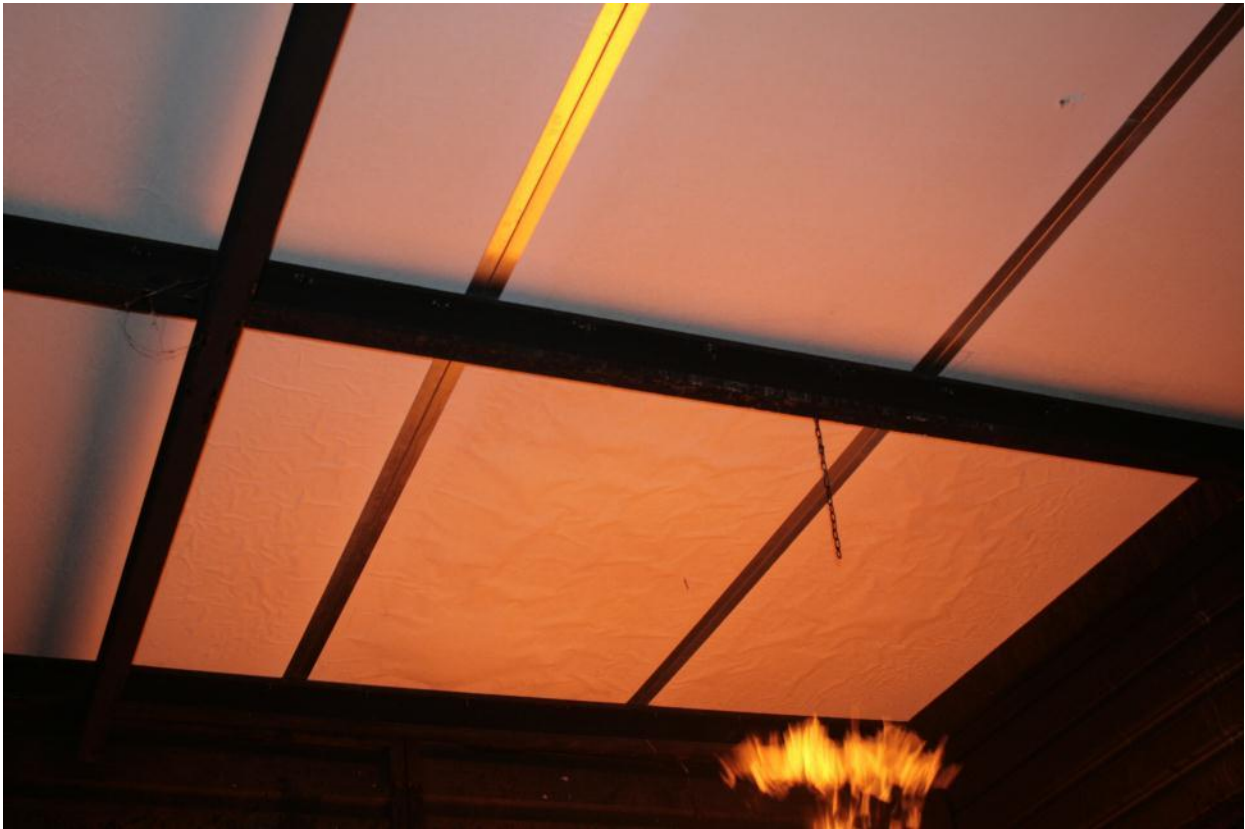
Figure 4.1.5: Note delamination of facing material above fire source.

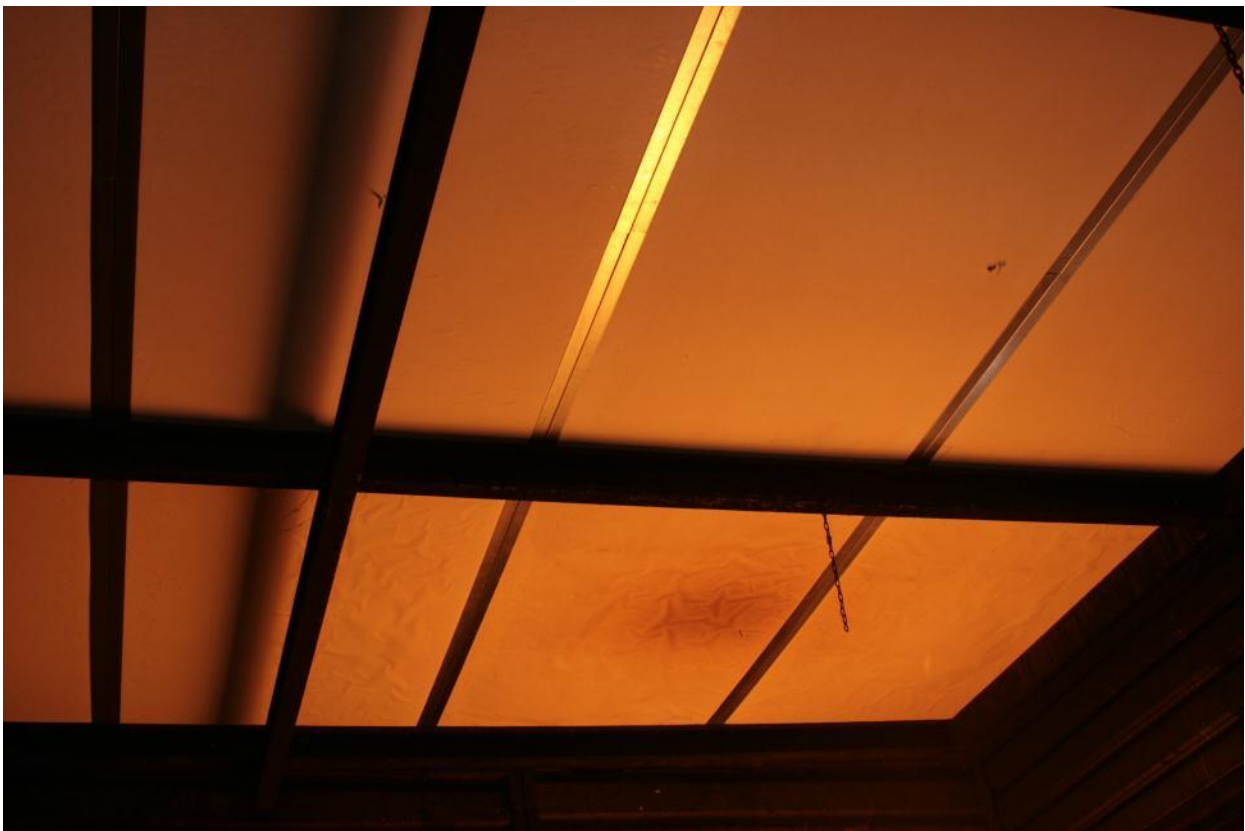
Figure 4.1.6: Note discoloration starting above fire source area

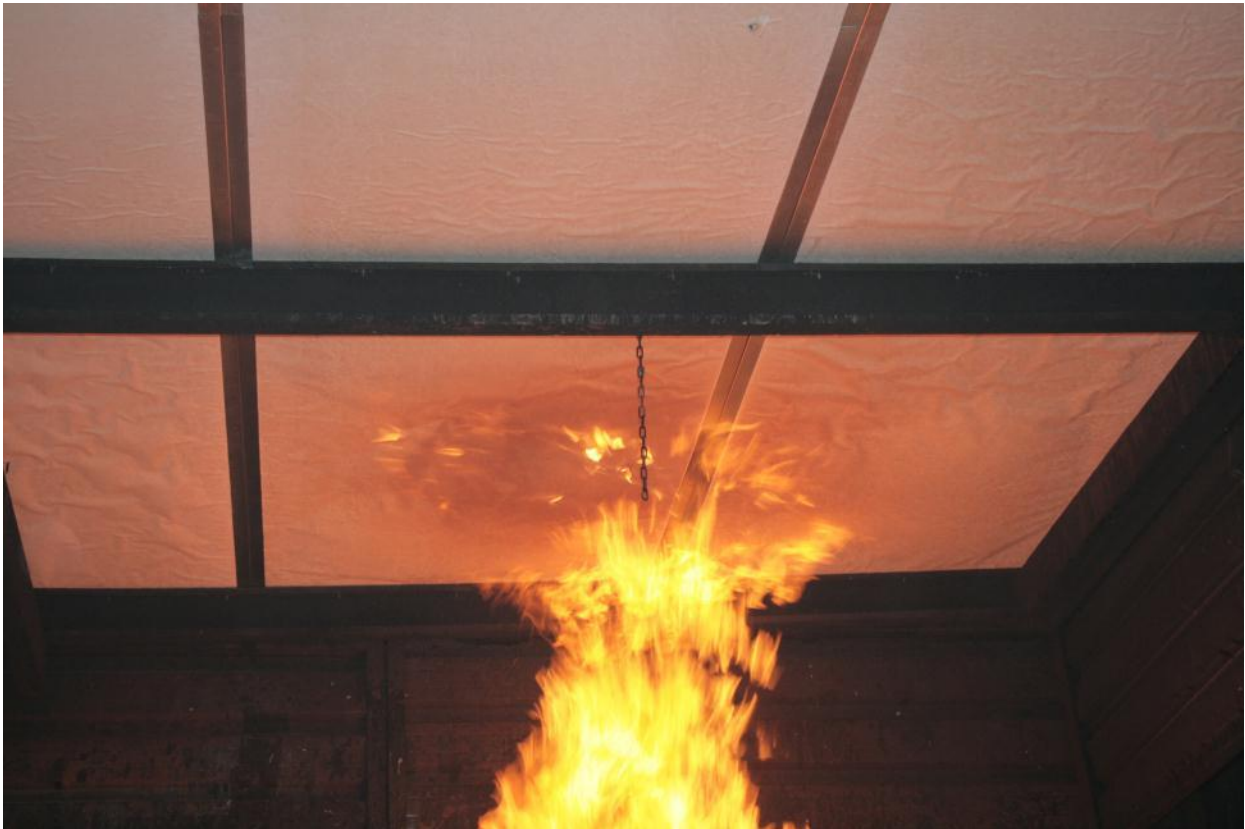
Figure 4.1.7: Note sporadic ignition above fire source area

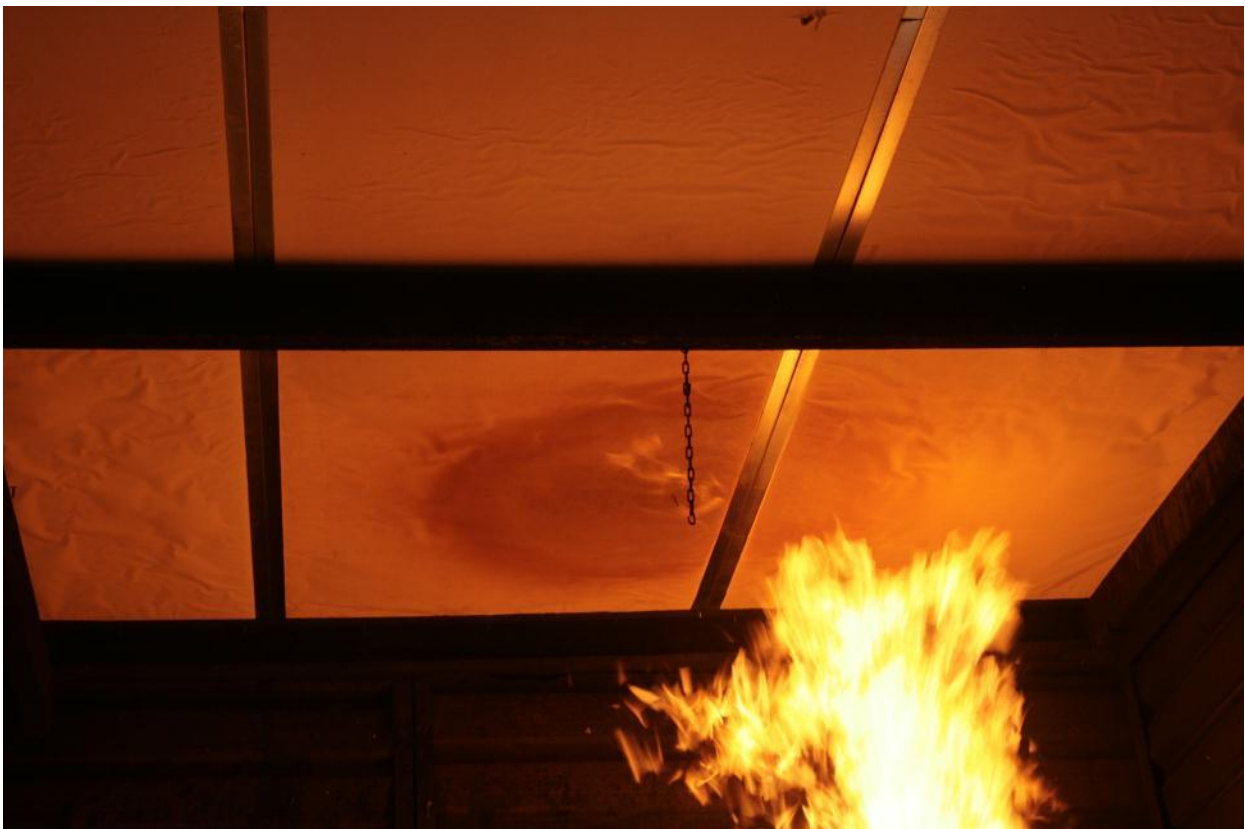
Figure 4.1.8: Sporadic ignition and widening discolouration area above fire source area

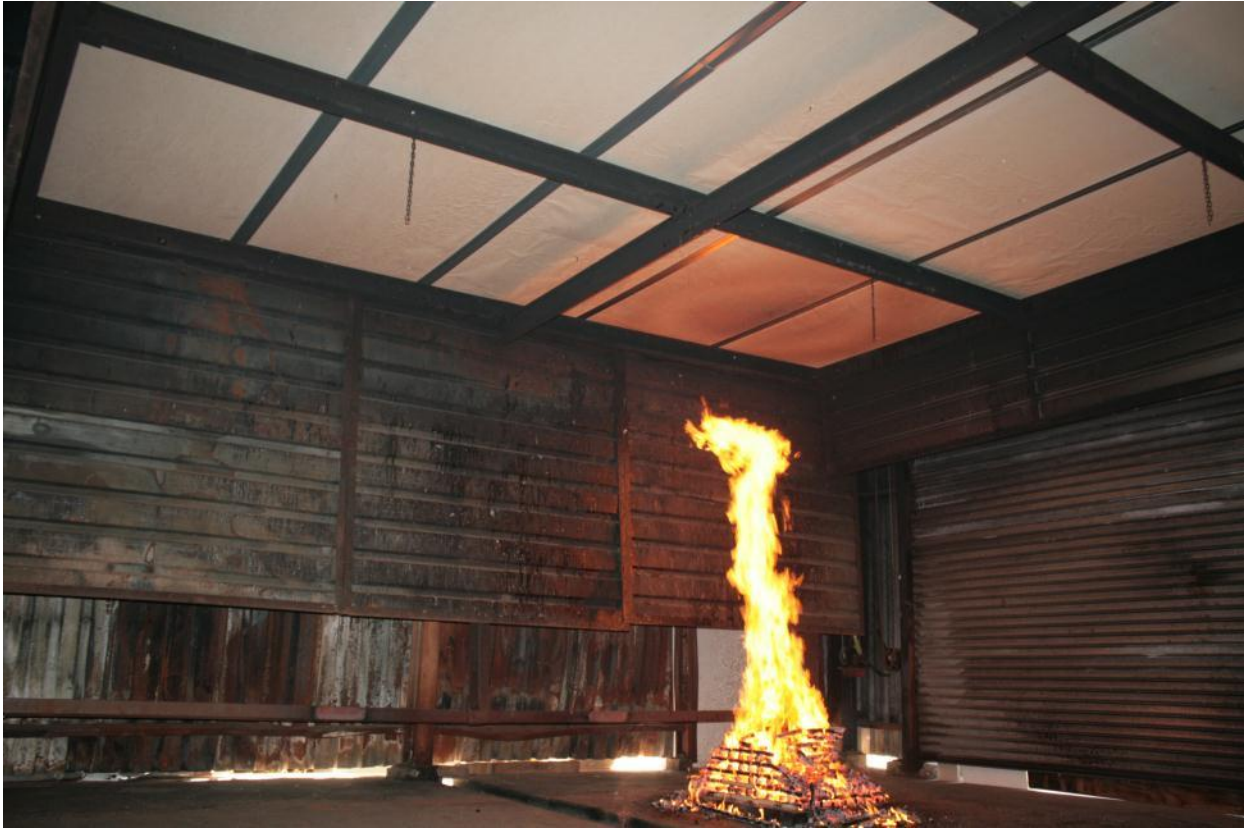
Figure 4.1.9: Fire starting to collapse

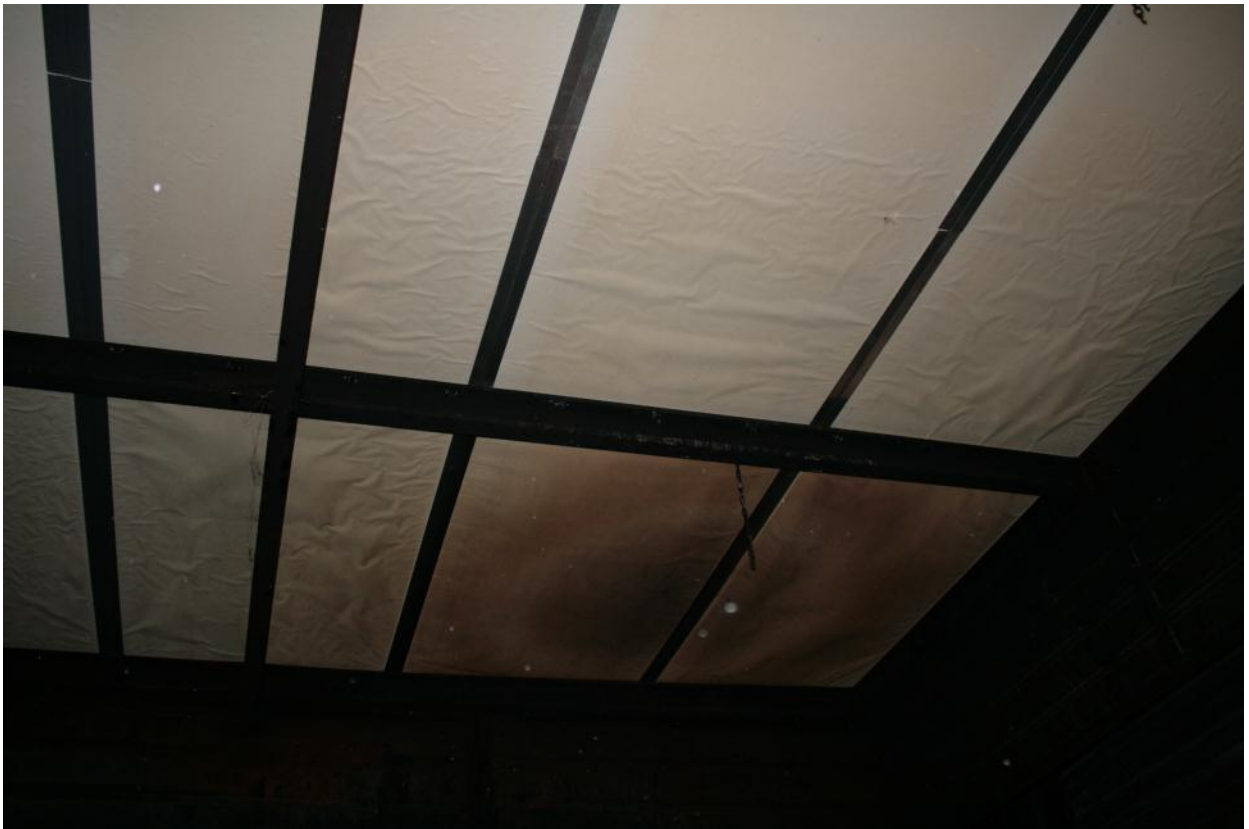
Figure 4.1.10: Test installation subsequent to completion of the test
