**TITLE** : Report on the evaluation of the fire properties of the **RIGIFOAM** product **LAMBDABOARD WM/MN (100 mm)** as under-roof insulation material using the **SANS 10177 – Part 11** test protocol in terms of **SANS 428**

**REQUESTED BY** : RIGIFOAM  
3 Detroit Street  
Apex  
**BENONI**

**CONTRACT No** : FTC14/120

**DATE** : 29 October 2014

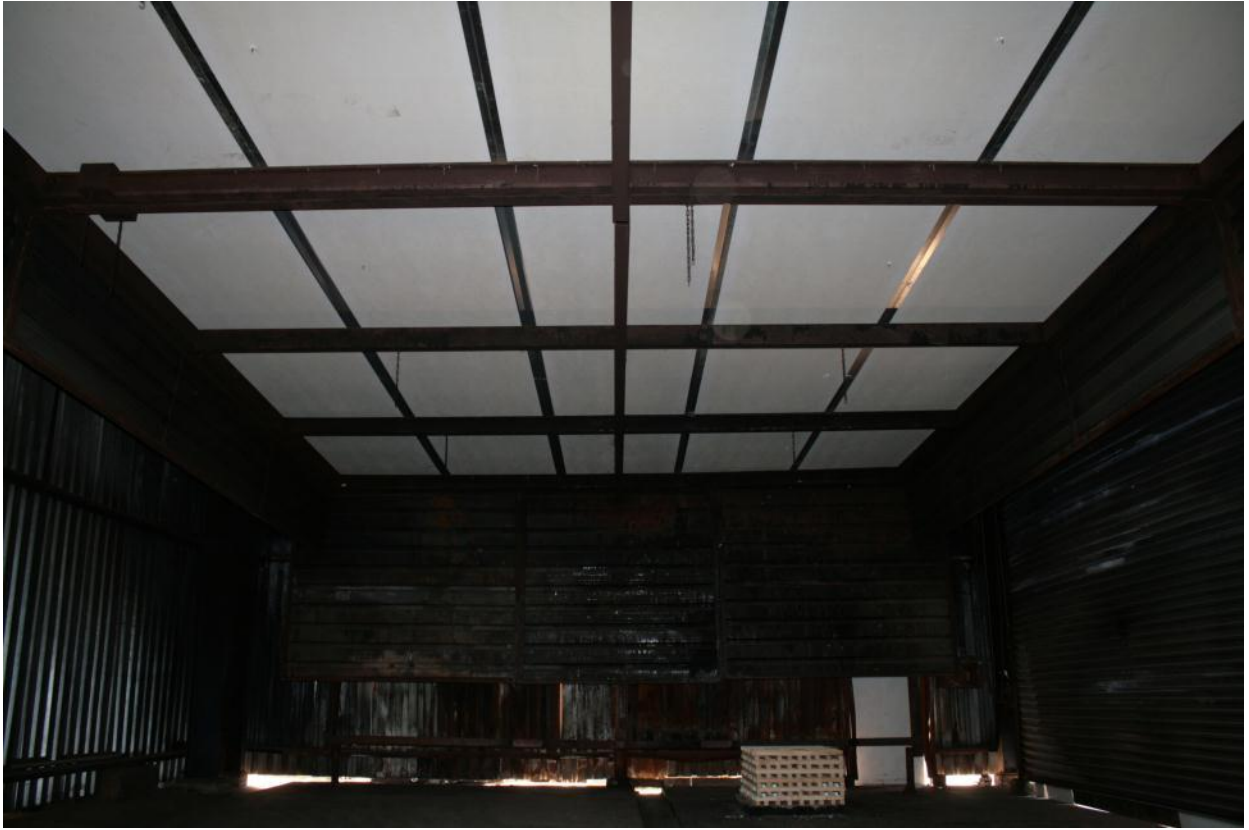
Figure 4.1.3: Test installation before ignition of the fire source

The installation before the ignition of the fire source is shown in Figure 4.1.3.
